## **Report on Macleay Flood of March, 2001**

### **River Levels, Rainfall and Recovery.**

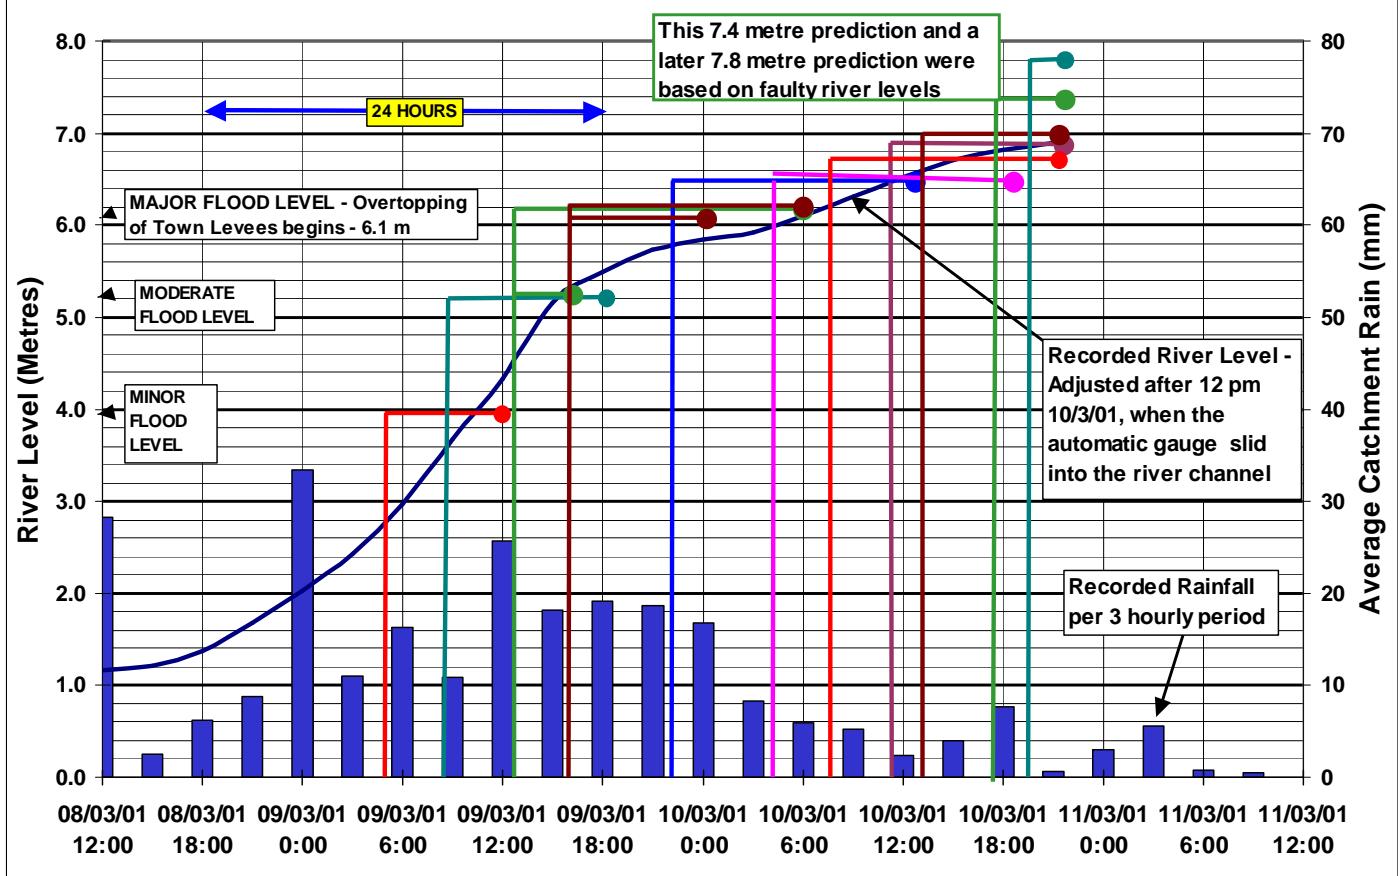
**Figure 6 : KEY FLOOD WARNINGS - KEMPSEY MARCH 2001**

On Friday 9<sup>th</sup> March, at 5:32am, a Flood Warning (#1) was issued, which predicted a minor flood level (4.0m) at KTB gauge by noon Friday. This warning stated the level at Georges Ck at 5:09am as 6.28m.

Warning #2 at 8:58am Friday, predicted a moderate level 5.2m at KTB gauge by 6pm, and higher if further rain.

Warning #3 at 12:27pm, Friday, predicted 5.18m at KTB gauge at 4pm, with a possibility of a level of 6.1m with further rain – a Major flood warning.

Warning #4 at 4:25pm, Friday, predicted 6m around midnight, 6.2m by 6am Saturday.

Warning #5 at 7:02pm, Friday, predicted peak near 6.0m with moderate flooding. Not expected to exceed 6m at Kempsey.

Warning #6 at 9.05pm, Friday, predicted to reach 6.2m on late Saturday afternoon with moderate to major flooding.

Warning #7 at 9.49pm, Friday, predicted peak to reach 6.5m at noon Saturday with major flooding.

Warning #8 at 1:08am Saturday, predicted peak of 6.5m on Saturday afternoon with major flooding.

Warning #9 at 4.18am, Saturday, predicted peak of 6.5m on Saturday afternoon with major flooding.

Warning # 10 at 7:20am Saturday, predicted 6.7m at 8pm Saturday, major flooding

Warning #11 at 10:52am predicted, 6.9m at 11pm.

Warning # 12 at 12:55pm predicted, 7.1m at 9pm.

The Kempsey Traffic Bridge Gauge malfunctioned from about mid-day Saturday, causing much higher predictions by the Bureau of Meteorology than the actual levels. A manual read was finally able to be made at 10:55pm confirming a level of 6.7m at that time. It appears the flood peaked at 6.9m between 9pm and 10pm Saturday evening (the 10<sup>th</sup>). Overtopping of all the town levees and inundation of the Kempsey CBD did occur. Belgrave Street and Forth Street were impassable for about 24 hours. Water slowly receded in the river, and below the top of all the levee banks, but was unable to drain from the town until the river receded at First Lane.
